Minute 319 Colorado River Delta Environmental Flows Monitoring

Initial Progress Report

December 4, 2014

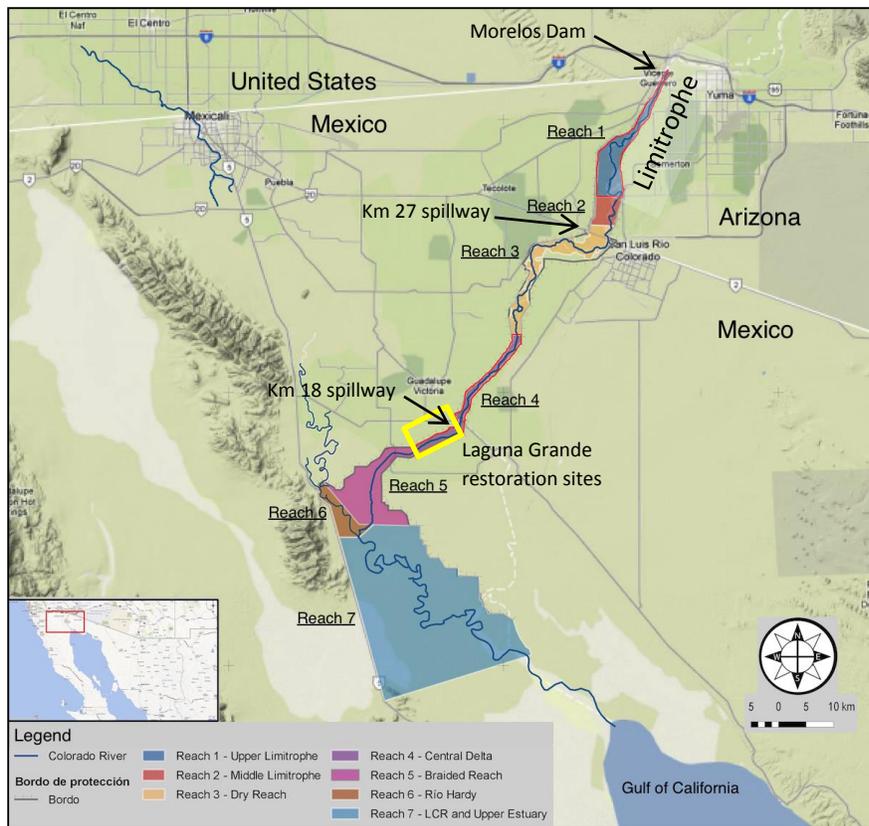
Figure 1. Colorado River Delta study reaches for Minute 319 monitoring activities.

The pulse flow delivered a total of 132¹ million cubic meters (mcm) (107,000 acre-feet [af]) to the riparian corridor of the Colorado River Delta, starting March 23 and ending on May 18, 2014. Water was delivered from Morelos Dam, and from the Km 27 spillway of Canal Reforma (river km 37; river mile 23) and the Km 18 spillway of Canal Barrote (river km 79; river mile 49) (Fig. 1 and Fig. 2).

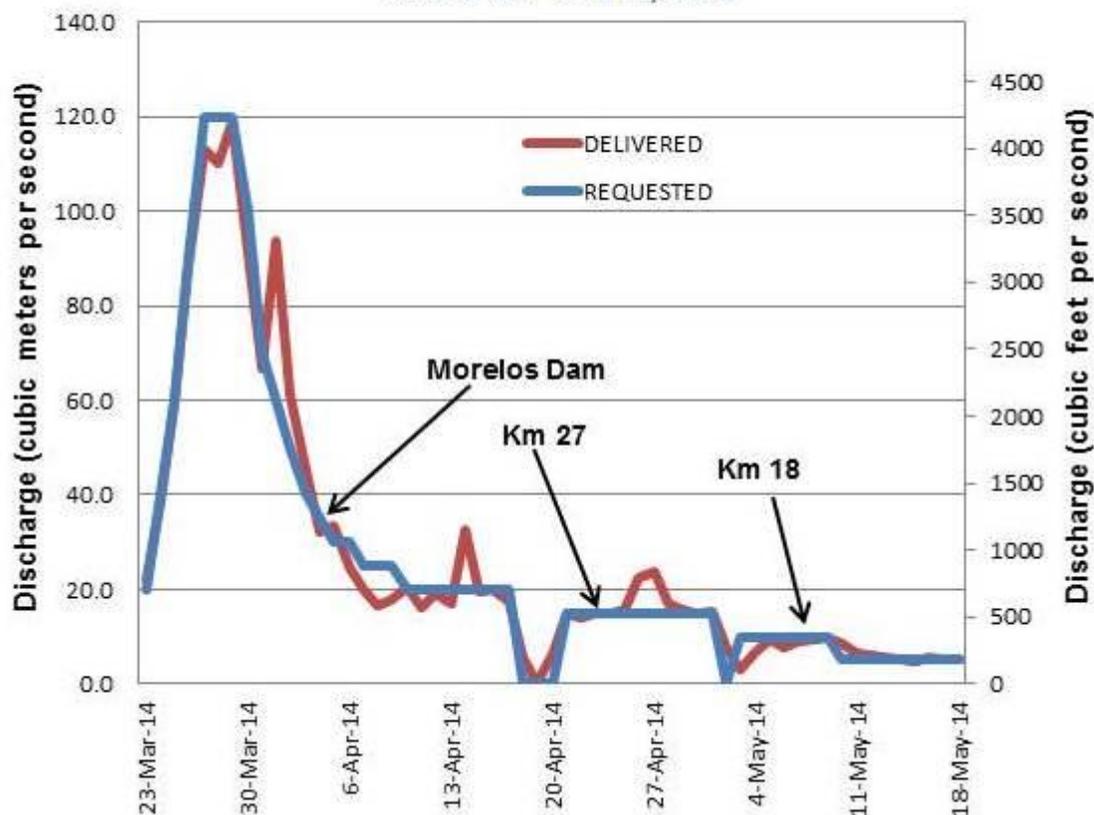
Figure 2. Delivered and requested pulse flow water deliveries to the study area. Scheduled Morelos Dam deliveries began on March 23 and ended on April 17; deliveries from the Km 27 spillway of Canal Reforma (at river km 37; river mile 23) began on April 13 and ended on May 1; deliveries from the Km 18 spillway of Canal Barrote (at river km 79; river mile 49) began on May 3 and ended on May 18, 2014. Source: Mexican Section of IBWC.

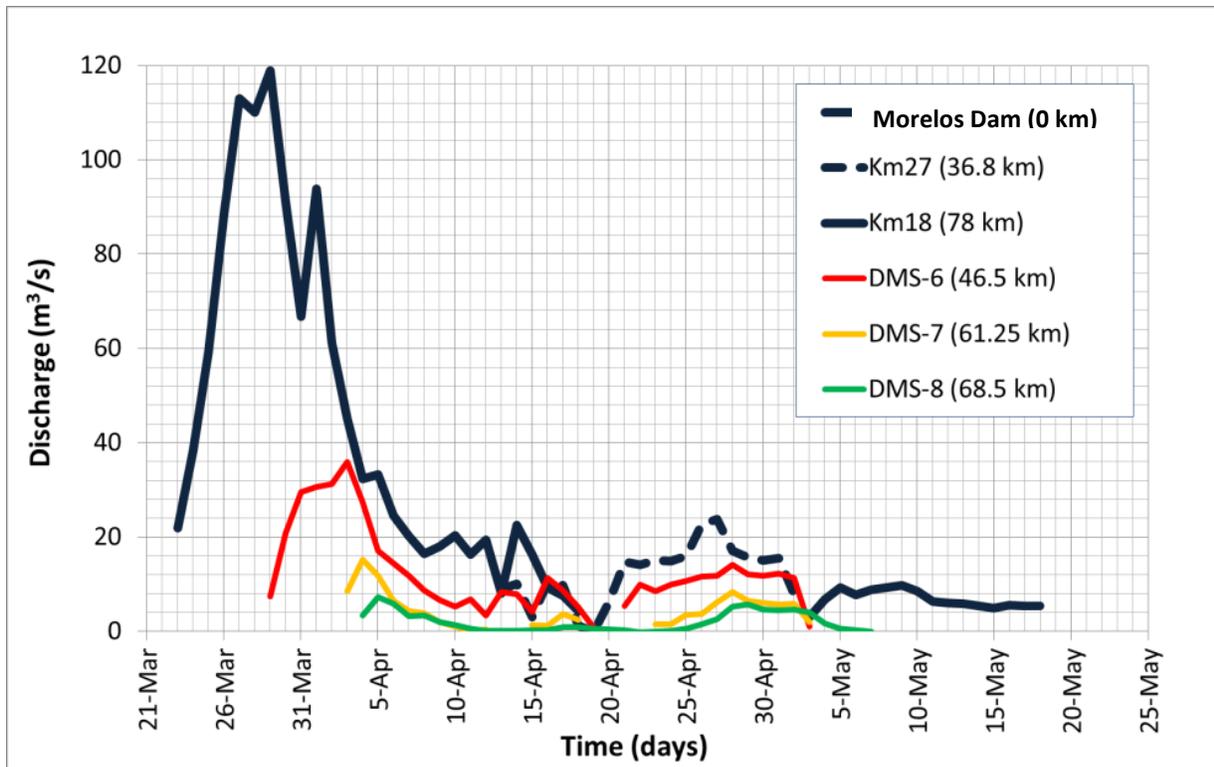
Figure 3. Variation in discharge through time at three discharge measuring stations (DMS 6, 7 and 8 – colored lines) in Reach 3 and discharges at Morelos Dam (Presa Morelos) and at the Km 27 and Km 18 spillways (black lines). Note the delay in the time of peak flows, and the reduced discharges at the measuring stations relative to the Morelos Dam and Km 27 spillway. Km 18 releases occurred downstream of DMS 8 and had no effect on the discharges measured upstream. Scale conversion: 100 m³/s (cubic meters per second) is approximately 3,500 ft³/sec (cfs). Distance information (in parenthesis) indicates distance of measuring stations from Morelos Dam, in kilometers.

Streamflow decreased rapidly with increasing distance downstream (Fig. 3). The pulse flow's surface water front advanced at highly variable rates (Fig. 4; from about 1 to 20 km per day or 0.5 to 13 miles per day), advancing faster when the channel surface was wet than when it was dry. The pulse flow reached the Laguna Grande restoration sites in Reach 4 on April 5-6. Pulse flow releases from the Km 18 spillway, which began on May 3, enabled the water front to resume its downstream flow; pulse flow water connected with tidal water from the Gulf of California in the afternoon of May 15, 2014 (Fig. 5).

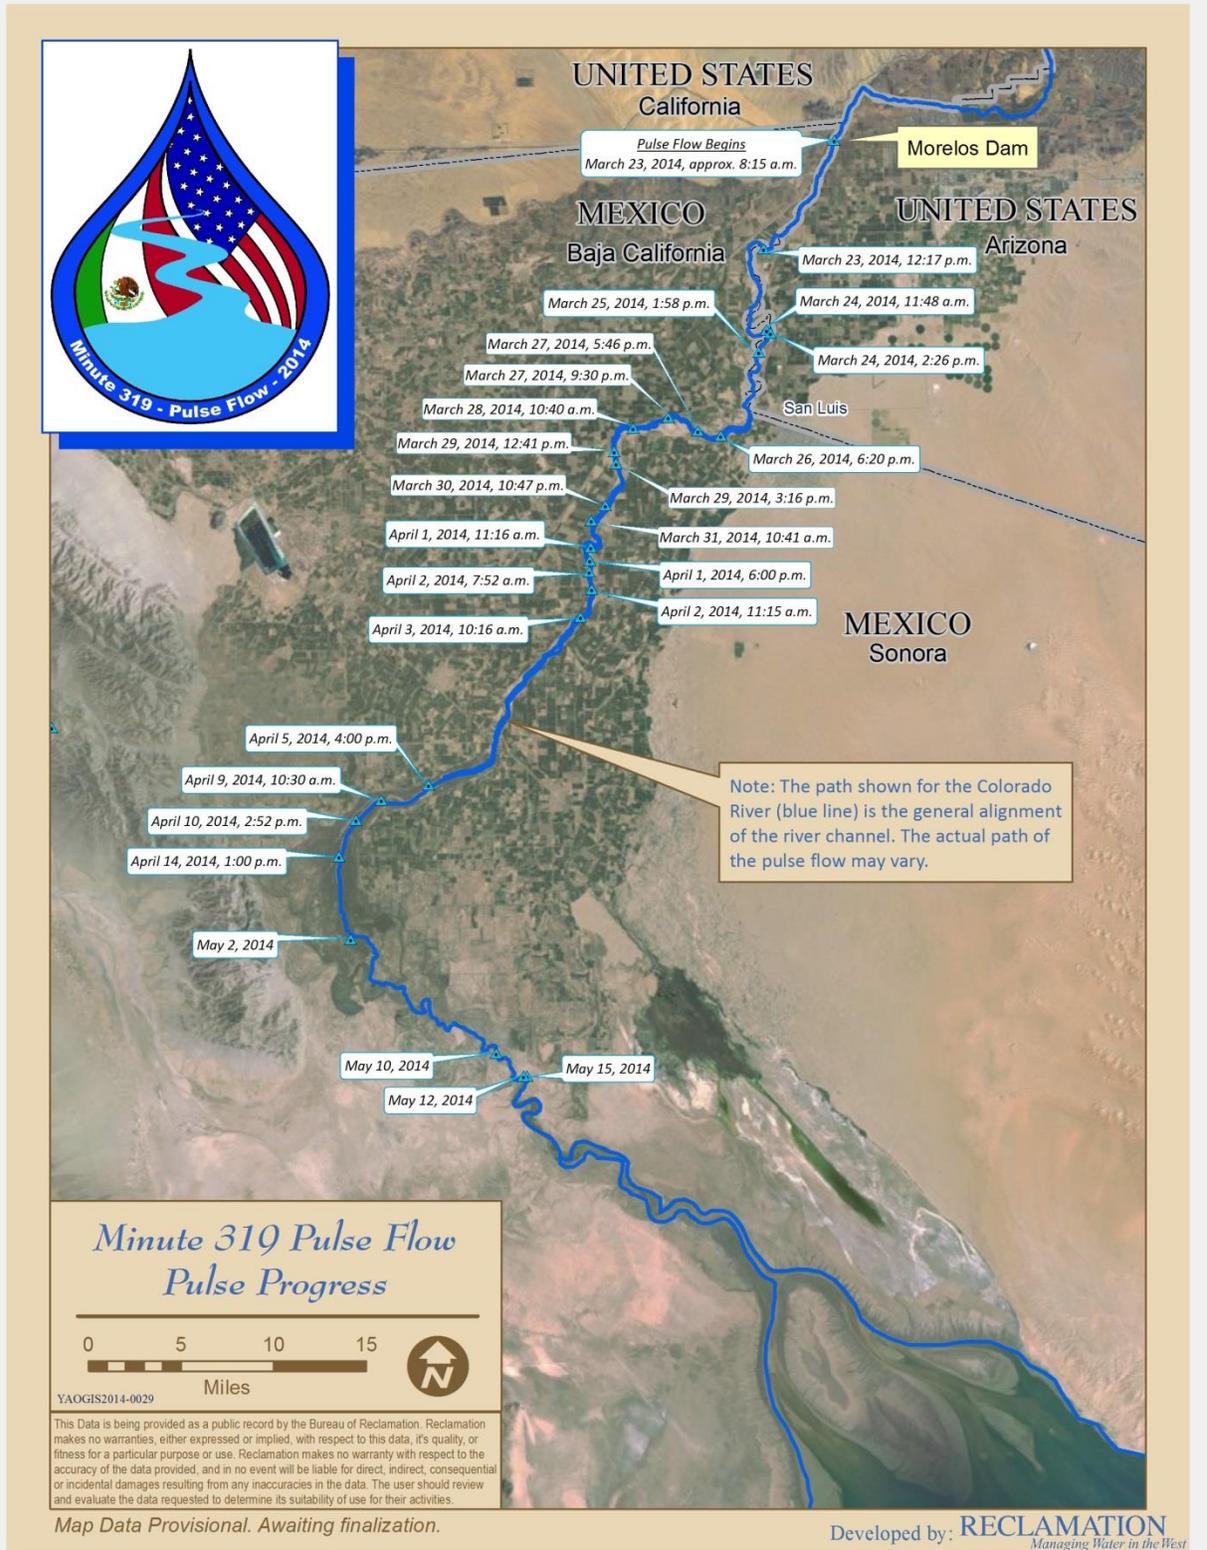
Figure 4. Progress of surface pulse flow water. Source: U.S. Department of the Interior, Bureau of Reclamation.

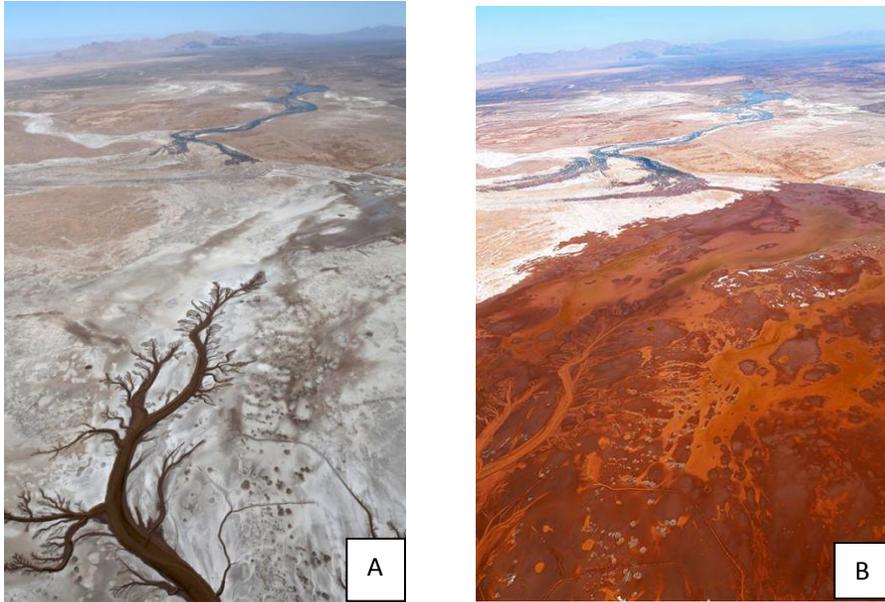
Figure 5. View looking north, from tidal waters of the Gulf of California (lower) to approaching Colorado River pulse flow (upper). **A.** Tidal channel (lower) and Colorado River (upper) May 13, 2014. **B.** Flooded area at high tide (lower, muddy water) connected with pulse flow of Colorado River (upper, blue water). May 15, 2014. Both images by Francisco Zamora, Sonoran Institute, with aerial support from LightHawk.

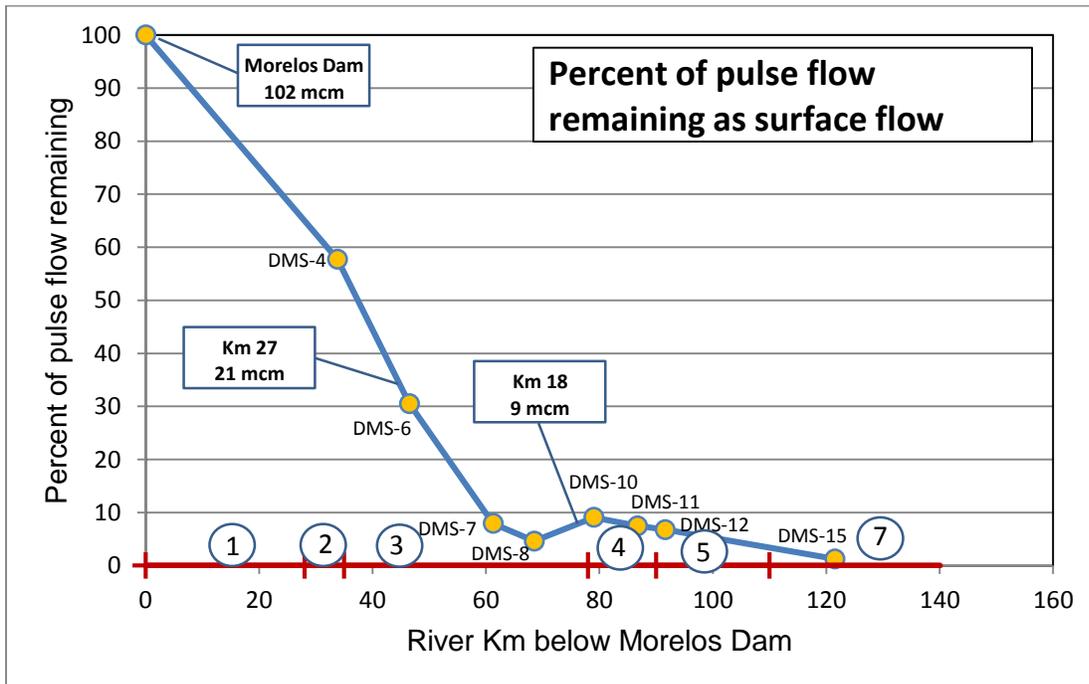
Figure 6. Percentage of total pulse flow remaining as surface flow with increasing distance (as river km) downstream from Morelos Dam. Morelos Dam released 102 million cubic meters (mcm) = 83,000 acre-feet (af); Km 27 spillway released 21 mcm = 17,000 af; Km 18 spillway released 9 mcm = 7,000 af. DMS numbers refer to discharge measuring stations. Circled numbers between red tick marks indicate river reaches. Distance scale: 60 river km = 37 miles; 100 km = 62 miles.

Most of the pulse flow's water infiltrated to groundwater, transpired from plants, evaporated from soil and water surfaces, or was retained in soil and topographic depressions. A significant portion of the pulse flow water infiltrated into the aquifer beneath Reaches 1, 2 and 3. More than 90 percent of the water released from Morelos Dam and Km 27 spillway did not flow farther than river km 60 (river mile 37), 26 km (16 mi) downstream of the Southerly International Boundary (Fig. 6).

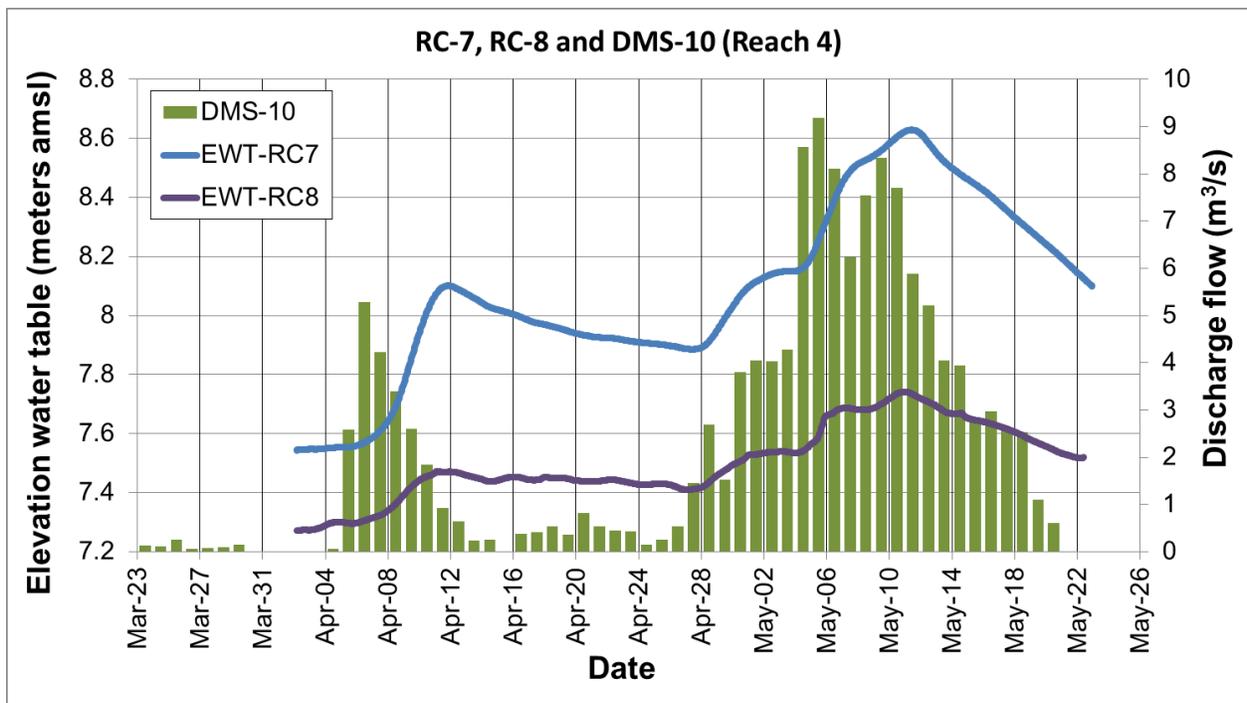
Figure 7. Example of groundwater response to pulse flow in Reach 4. Green bars show surface discharge at DMS 10 through time. Solid lines show elevation of water table (EWT) above mean sea level at two locations downstream (RC-7, RC-8) of DMS 10. English equivalents: 8.8 m = 29 ft; 10 cms = 353 cfs.

The water table in all reaches rose in response to the pulse flow. Aquifer response to the pulse flow varied along the river, across transects, and with time. Generally, groundwater behavior mimicked surface-water fluctuations. Groundwater effects dampened with increasing distance from the active channel. The initial slow groundwater-level rise in dry sediment was followed by more rapid changes in groundwater levels as the sediment saturated. The water table then declined at varying rates after its peak (Fig 7). Quantitative models are being developed to describe and predict infiltration behavior of surface water under various conditions.

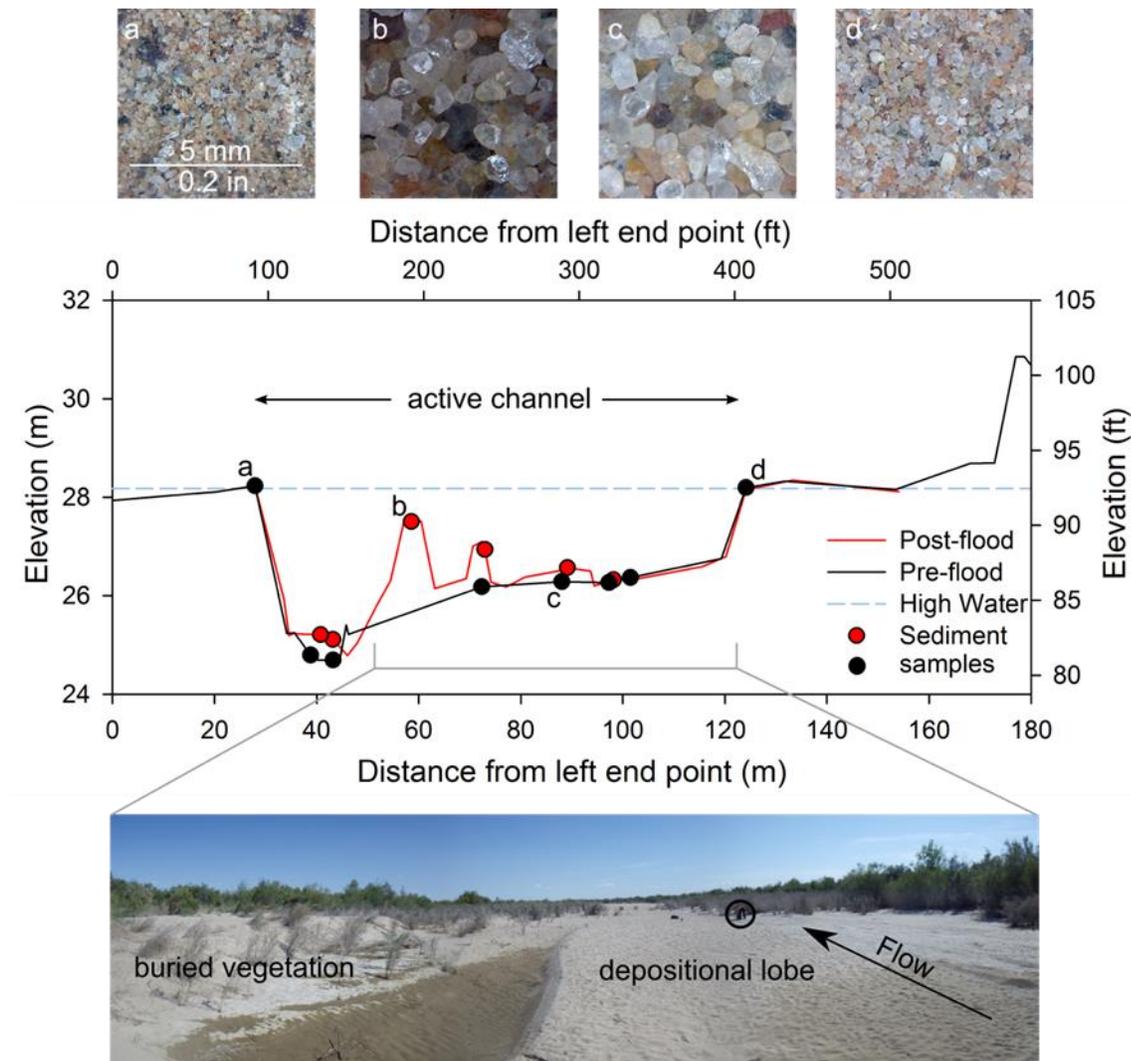
Figure 8. Example of channel change at USGS cross section 12 in the Limitrophe reach ($32^{\circ} 34' 20''$ N; $114^{\circ} 48' 36''$ W [NAD83]). (Top) Microscope camera (“sandcam”) images of sediment at different locations across the channel as indicated in the middle panel. (Middle) Pre- and post-flood surveys showing net aggradation at this cross-section. Black and red dots show the location of pre- and post-flow sediment samples, respectively. Vertical axes show elevation above mean sea-level (NAVD88). (Bottom) Image looking downstream at the cross-section; a person is circled for scale at the location of the cross-section.

Channel and floodplain sediments are predominantly sand. In places, the pulse flow scoured sediment to depths of approximately one meter (3.3 ft), and deposited about two meters (6.6 ft) of sediment farther downstream. Scour and deposition modified the channel bed topography (Fig. 8), but bank erosion of the existing channel was minor. Models are being developed of sediment movement under different flow regimes in order to understand and predict geomorphic changes resulting from river flows.

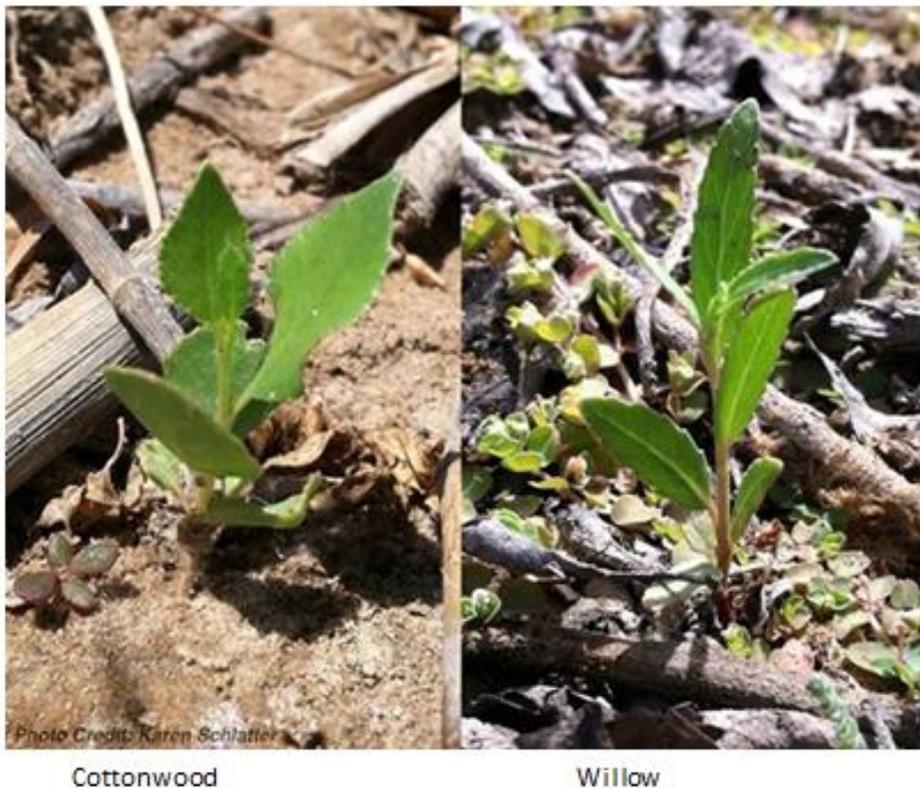
Figure 9. Cottonwood (left) and willow (right) seedlings in the Laguna Grande restoration site on May 17, 2014, approximately 1.5 months following the arrival of the pulse flow to the site. Seedlings are approximately 4-5cm (1.8 inches) in height.

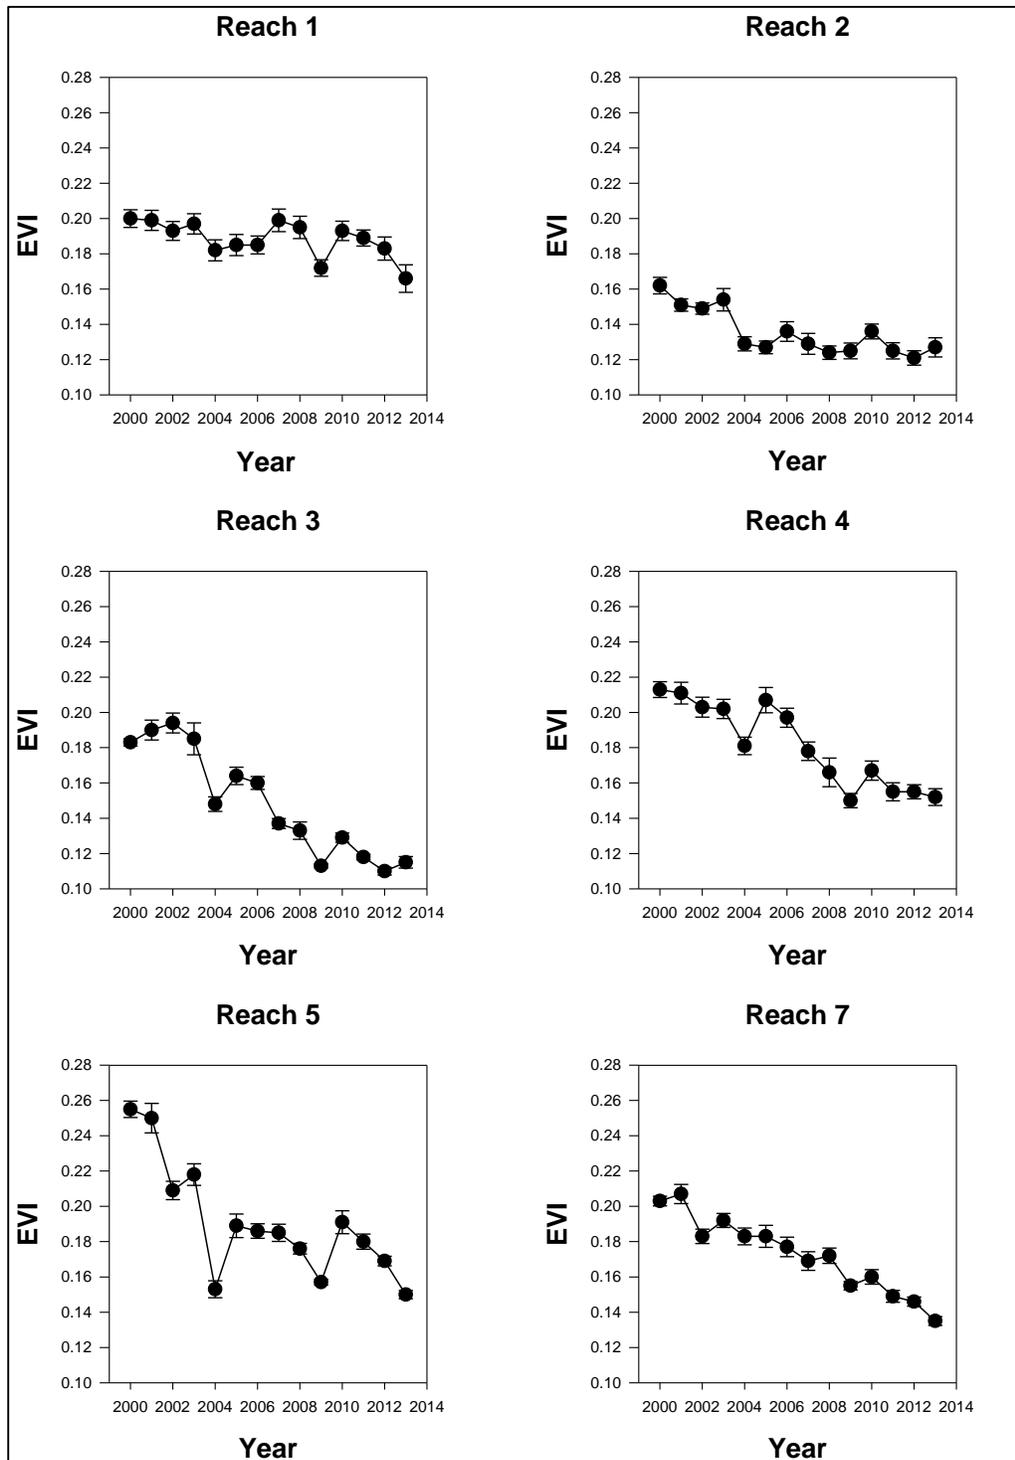
Figure 10. Decrease in the Enhanced Vegetation Index (EVI) from MODIS imagery in Colorado River Delta river reaches, 2000- April 9, 2014. Annual means are based on 23 16-day composite collections at 5 sites per reach.

Error bars are standard errors of means. Across reaches, EVI decreased by 31%, which corresponds to a 59% decrease in green foliage density after subtracting out the value for bare soil (about 0.1).

Growth and survival of native and non-native seedlings will mostly depend on soil moisture derived from groundwater. Green vegetation, as measured by the MODIS satellite sensor, decreased steadily in all river reaches from 2000 through April 9, 2014 (Fig. 10), indicating increased plant water stress. Preliminary remote-sensing data (June 2014) and aerial observations suggest that greenness has increased since the pulse flow. Landsat 8 imagery over all river reaches showed a 36% increase in NDVI (Normalized Difference Vegetation Index - a measure of greenness) in June, 2014 compared to June, 2013. NDVI increased in all reaches except Reach 4, where vegetation had been cleared prior to the flow

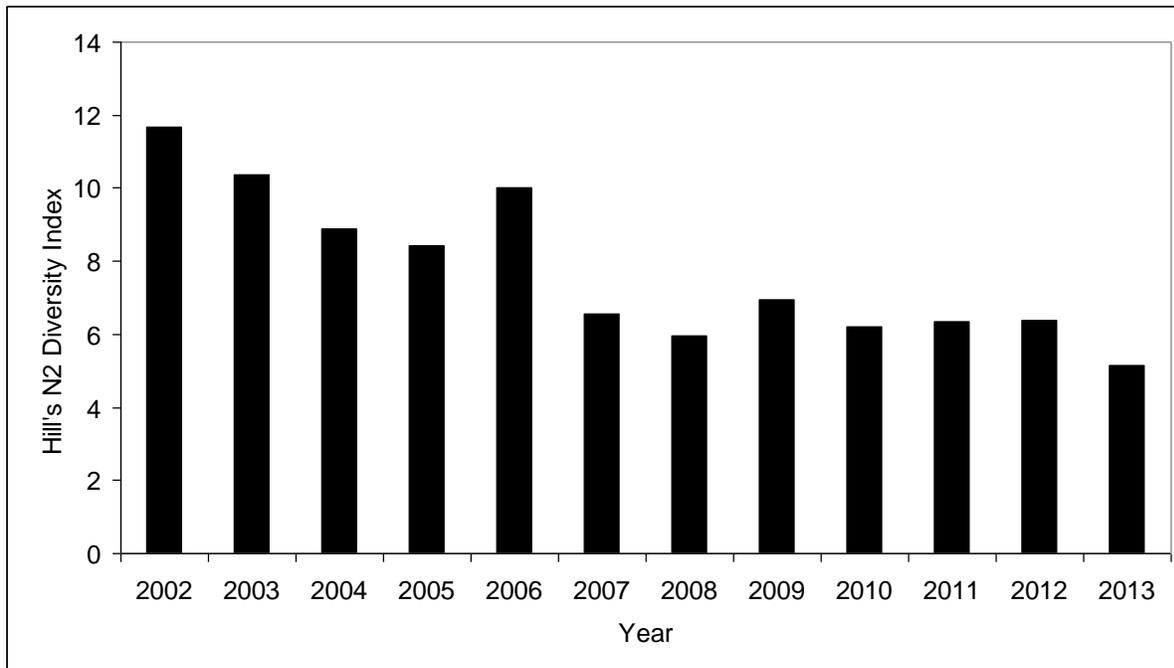
Figure 11. Average avian diversity (Hill's N2 Diversity Index) per point from 2002 to 2013 at 136 survey sites along the floodplain of the Colorado River in Mexico, between the Southerly International Boundary and the confluence of the Colorado with the Hardy River.

Average abundance of birds in the riparian corridor has increased from 2002 to 2013, but species diversity has decreased (Fig. 11) and composition has changed. The abundance of riparian-dependent land birds and breeding water birds has declined, while the abundance of birds related to agricultural and urban development, exotic birds, and raptors has increased. Spring 2014 surveys were conducted during the pulse flow; winter 2014 surveys were conducted in January 2014 before the pulse; summer 2014 surveys were conducted after the pulse. No changes were observed in the spring 2014 surveys in the riparian zone relative to the previous spring. Preliminary analyses suggest an increased presence of migratory birds along open water areas but the abundance of migratory birds is controlled by many factors in addition to changes in this local habitat. Bird abundance and species richness were higher in the active restoration sites than throughout the rest of the floodplain. Bird populations are expected to change if existing and new vegetation responds to the pulse flow. Such changes should be evident from longer-term monitoring activities.
