Analysis of the Transport and Fate of Metals Released from the Gold King Mine in the Animas and San Juan Rivers

EXECUTIVE SUMMARY

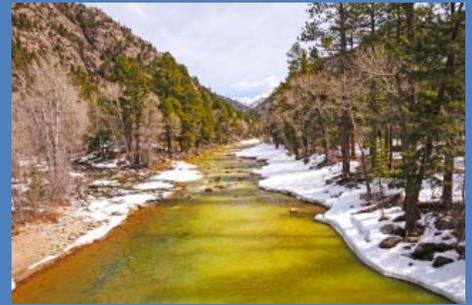
GKM Release

9 hours of pressurized mine impacted waters scoured the hillside with approximately **1% total metal load** coming from inside the mine and **99% total metal load** from a waste pile located on the hillslope outside the mine.

EPA estimates that one percent of the metals came from inside the mine itself while 99 percent of the metals were scoured from the waste pile on the hillslope and the Cement Creek streambed. Approximately 15,000 kg, or 3 percent, of the original total metal mass was initially in dissolved form and 475,000 kg was in a fine, clay-like solid form. Generally, dissolved metals are considered more toxic, more reactive, and more mobile than solid metals.

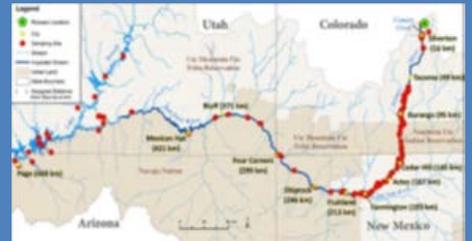
EPA estimates that **approximately 490,000 kg (close to 540 tons) of metals**, dominated by iron and aluminum, entered into the Animas River over the 9-hour period of the release.

The total amount of metals entering the Animas River following the release was comparable to the amount of metals carried by the river in one to two days of high spring runoff.
